Site 6

Former Fire Training School

Former Naval Station Treasure Island

BCT Meeting Update

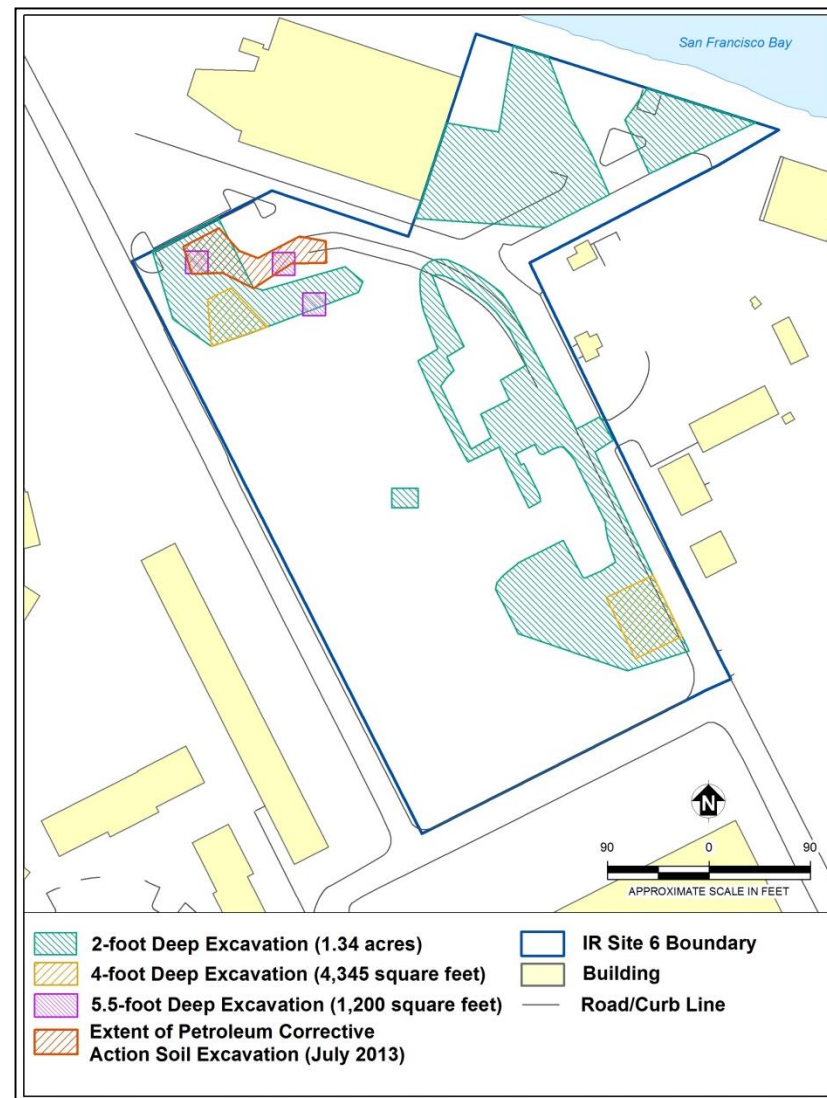
Site 6 Record of Decision

Soil Remedy

- Excavation and off-site disposal of soil in certain areas at depths up to 5.5 feet below ground surface
- Land Use Restrictions / Institutional Controls (ICs)

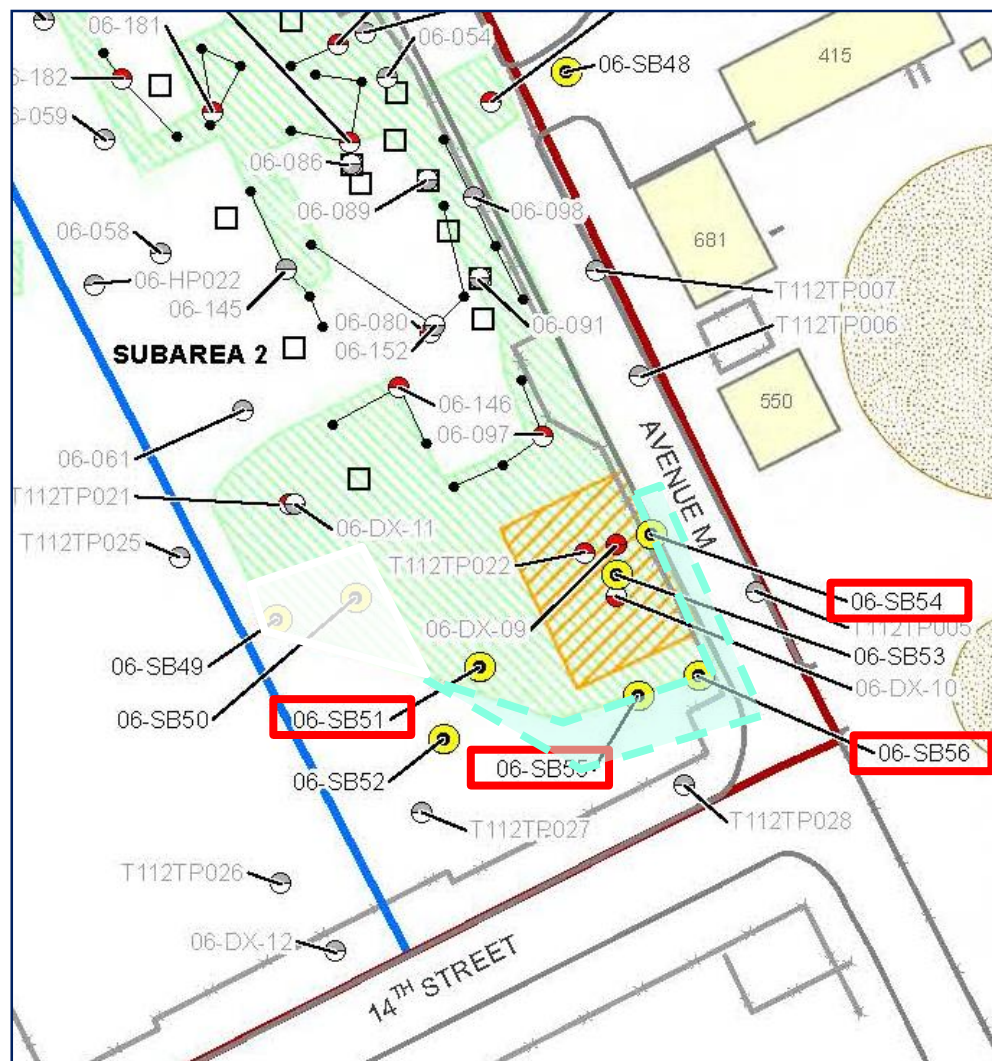
Site 6 Pre-Design Soil Sampling – Subarea 2

Purpose

- Refine Eastern and Southern Limits
- Vertical Delineation in Deeper Excavation Area

Results

- Elevated Dioxins Detected in 4 Sample Locations out of 8
- Excavation Reduction near 06-SB49 and 06-SB50
- Expand Southeastern Limits
- Vertical Delineation

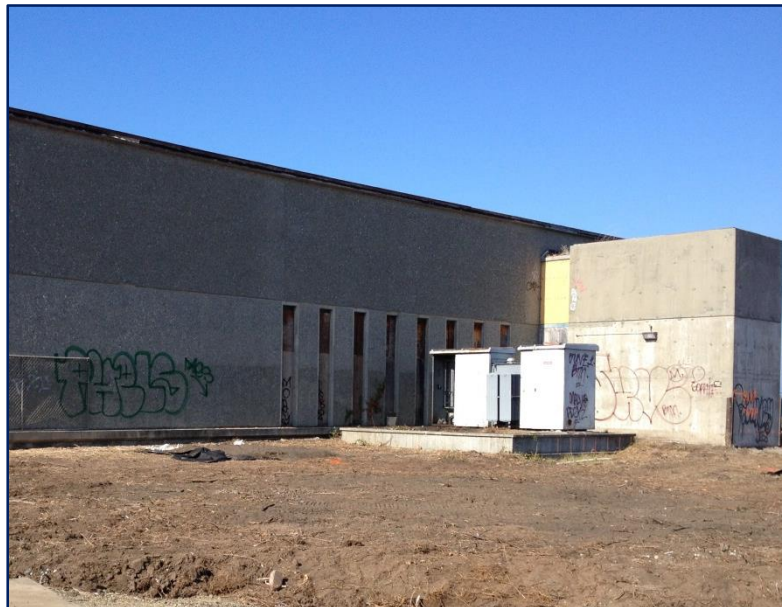
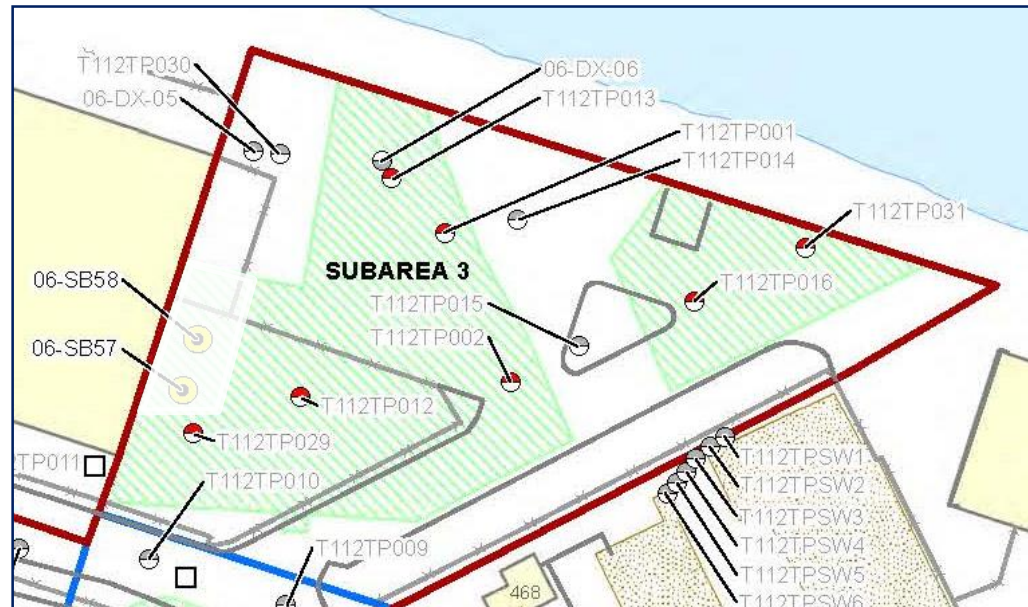
Site 6 Pre-Design Soil Sampling – Subarea 3

Purpose

- Shallow soil samples in hopes of reducing excavation near structures

Results

- No Elevated Dioxin Detections – Slight Excavation Reduction
- Structure (Transformer) Removed During Radiological Screening

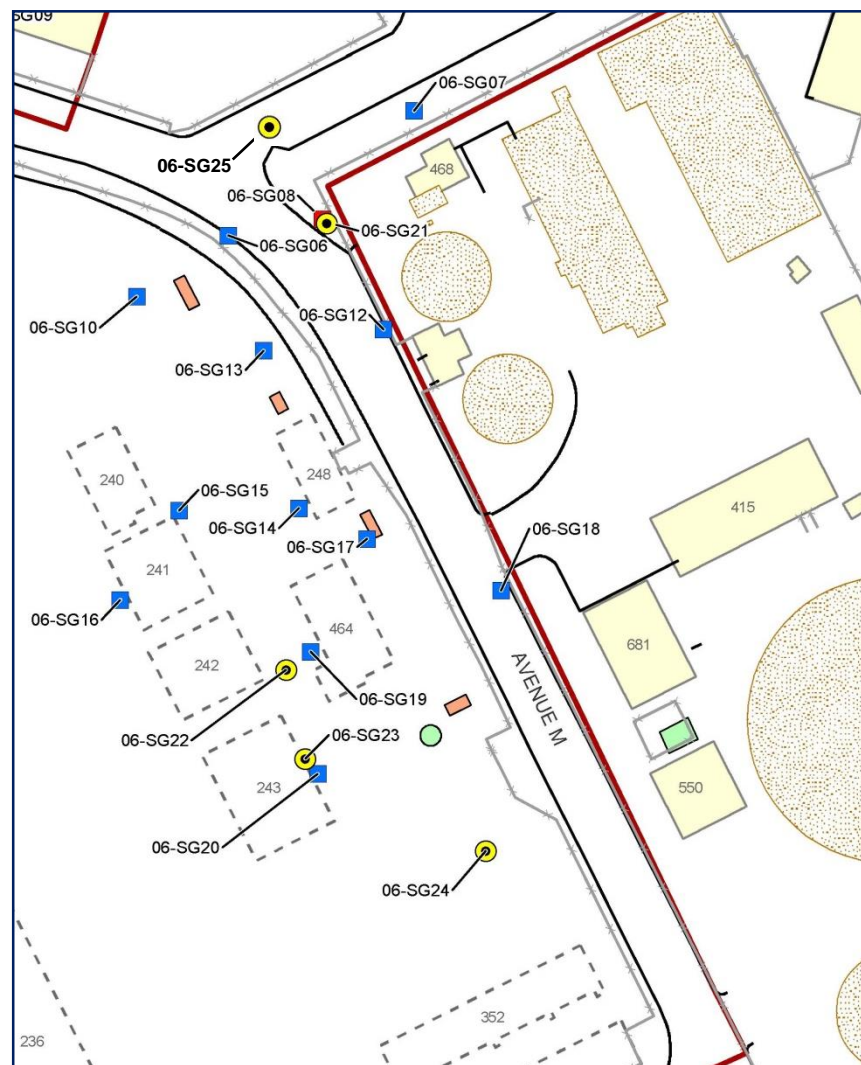
Site 6 Pre-Design Soil Gas Sampling – Subarea 2

Purpose

- Soil Gas Sampling for Naphthalene
- Historical Location 06-SG08
 - Detection of 34 J $\mu\text{g}/\text{m}^3$
 - Screening Level is 31.9 $\mu\text{g}/\text{m}^3$

Results

- No Detections of Naphthalene
- Lab Sample Analysis Error in 06-SG22 and 06-SG25
 - To Be Resampled During Remedial Action Activities

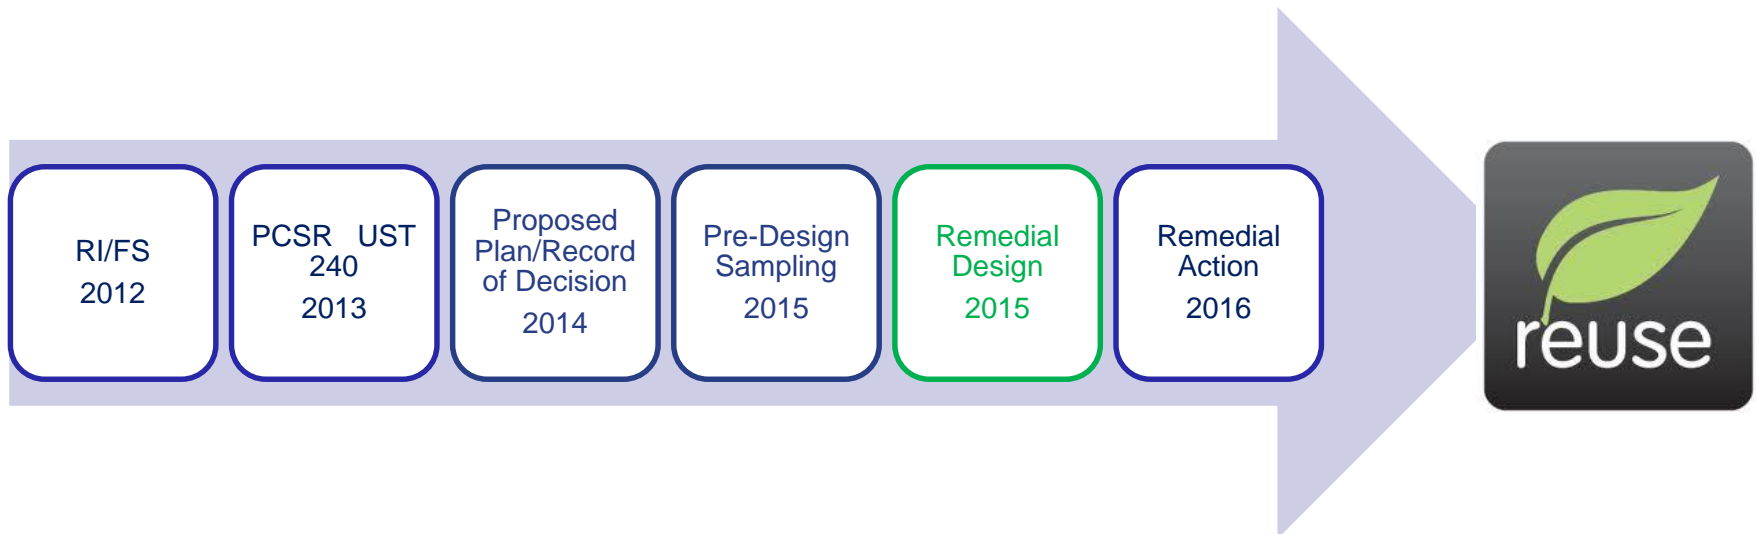
CERCLA Process

- Draft Remedial Design / Remedial Action Work Plan – November 2015
